John Deere 4320 Forward End Cover

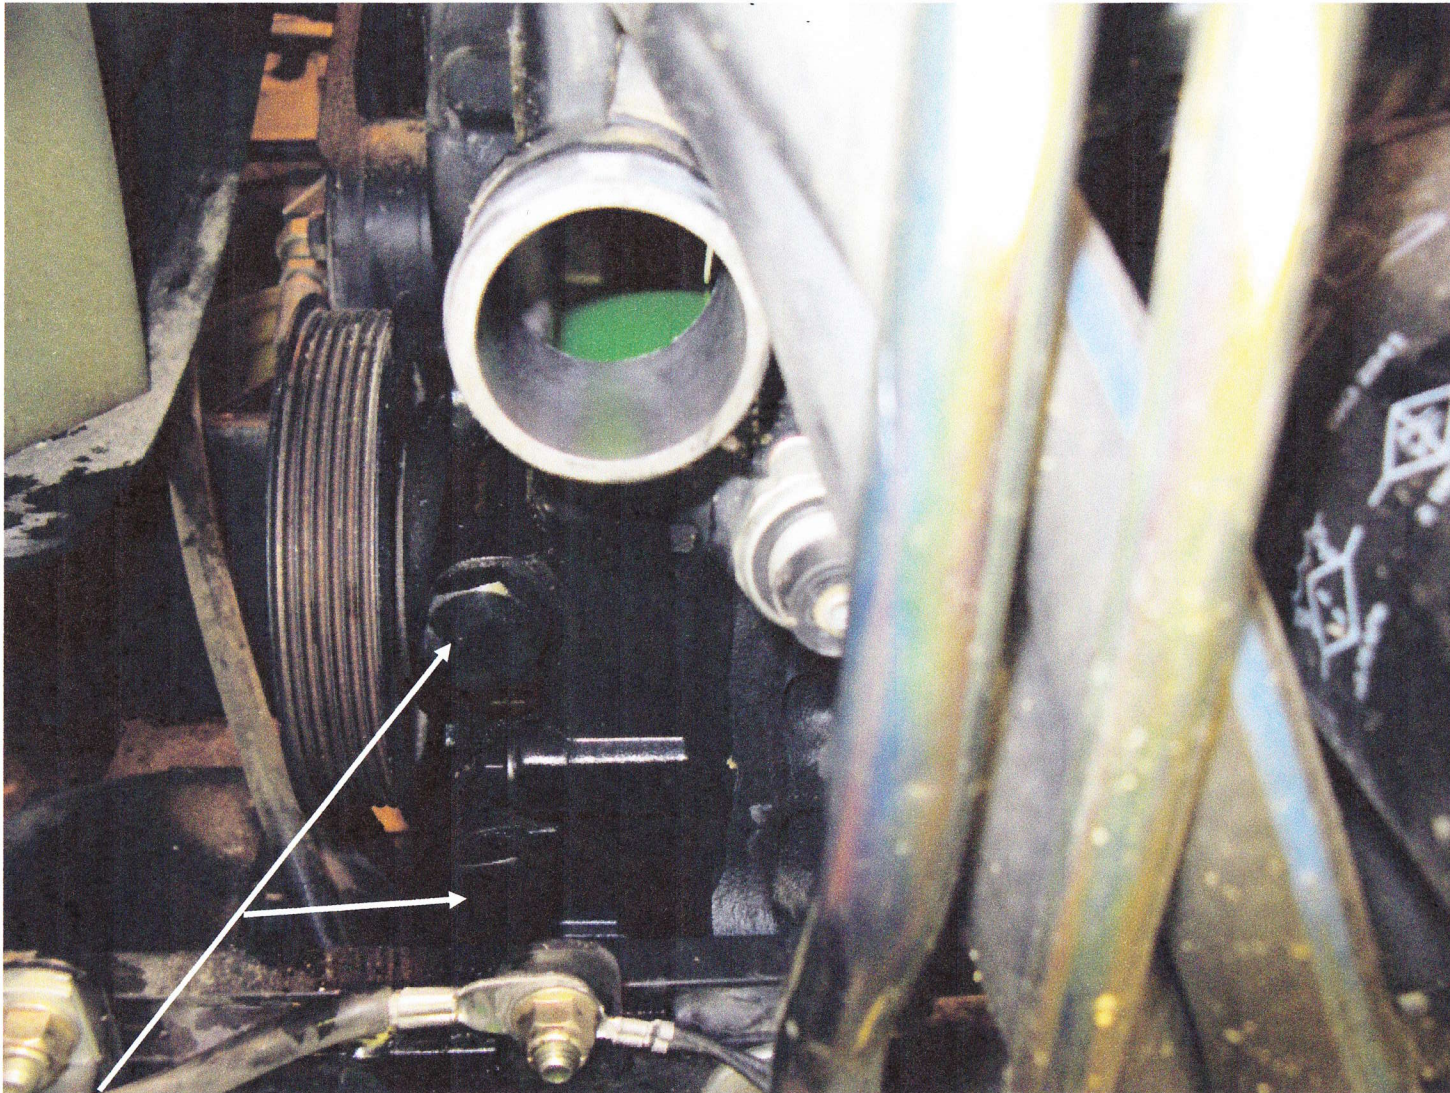
Machining appears to be shifted to the left, as noted by the overhang of the 2 threaded plugs as shown above. Visually the plugs appear to be not machined on the center line of the cast bosses. This could explain the lack of machine clean up in the water pump mounting area.
