Dashboard Fault Code: s173 F31

DPF In temp sensor fault	DPF In temperature sensor signal global fault

Dashboard Fault Code: s173 F03

DPF In temp sensor high fault	DPF temp. sensor wiring or circuit failure

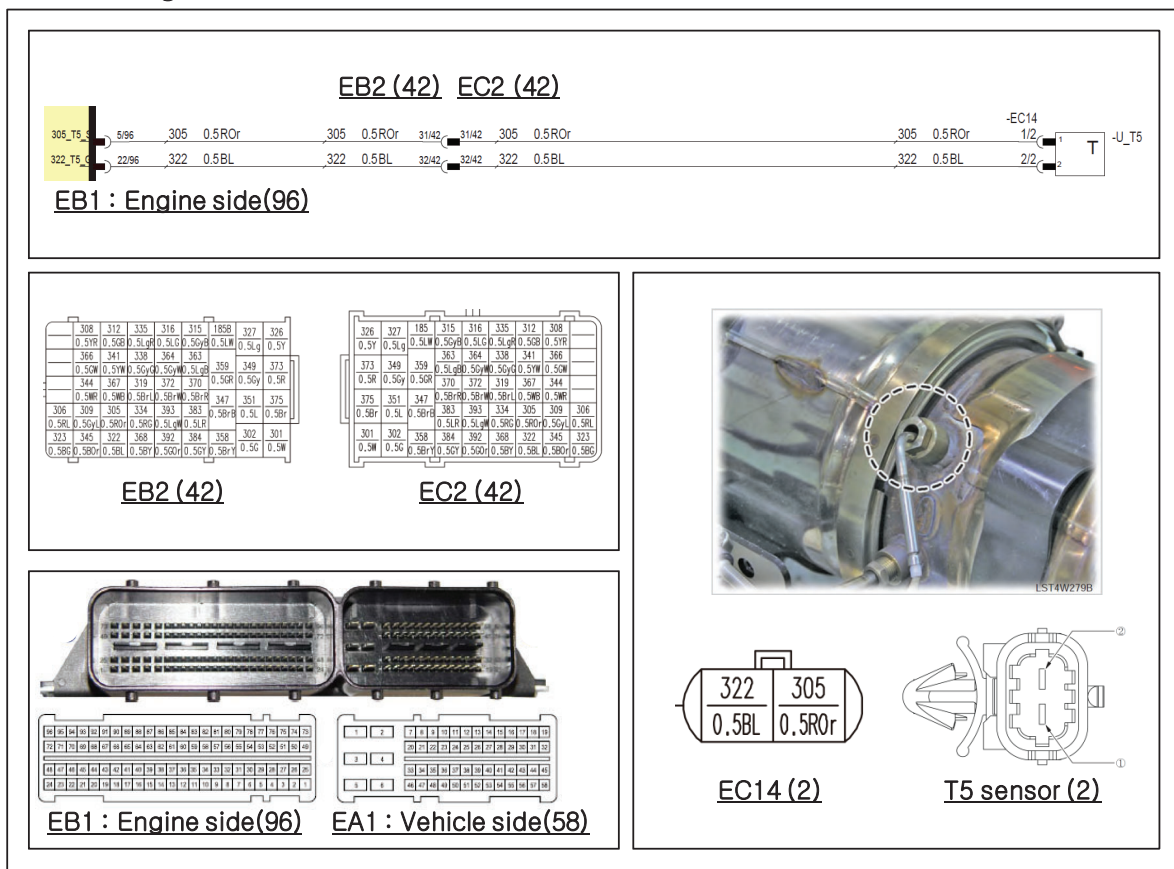
## Circuit Diagram and Connector

1. DPF regeneration stop
2. EGR valve control stop

Stage	Check List	Corrective Measure	
		Yes	No
1	Read fault code. Vext fault present? (P0641, P0651, P0697)	Go to stage 2	Go to stage 3
2	Problem with one of the sensors causing loss of Vext: Disconnect sensors one by one checking if fault disappear to find which one is faulty. If no faulty found, check short circuit and isolation of Vext lines on the harness. Find the failure cause?	Change sensor or change harness	–
3	Check sensor connection. Sensor connection problem ?	Perform necessary repair	Go to stage 4
4	Check sensor resistance, <sup>1)</sup> If applicable. Resistance problem ?	Change sensor	Go to stage 5
5	Check ECU connection. Connection problem ?	Perform necessary repair	Go to stage 6
6	Check continuity and electrical isolation of harness. <sup>2)</sup> • Check EC15 connector 1/2pin on EC2 connector 31/42pin • Check EC15 connector 2/2pin on EC2 connector 32/42pin • Check EB1 connector 5/96pin on EB2 connector 31/42pin • Check EB1 connector 22/96pin on EB2 connector 32/42pin Harness problem?	Change harness	Call Hot–line

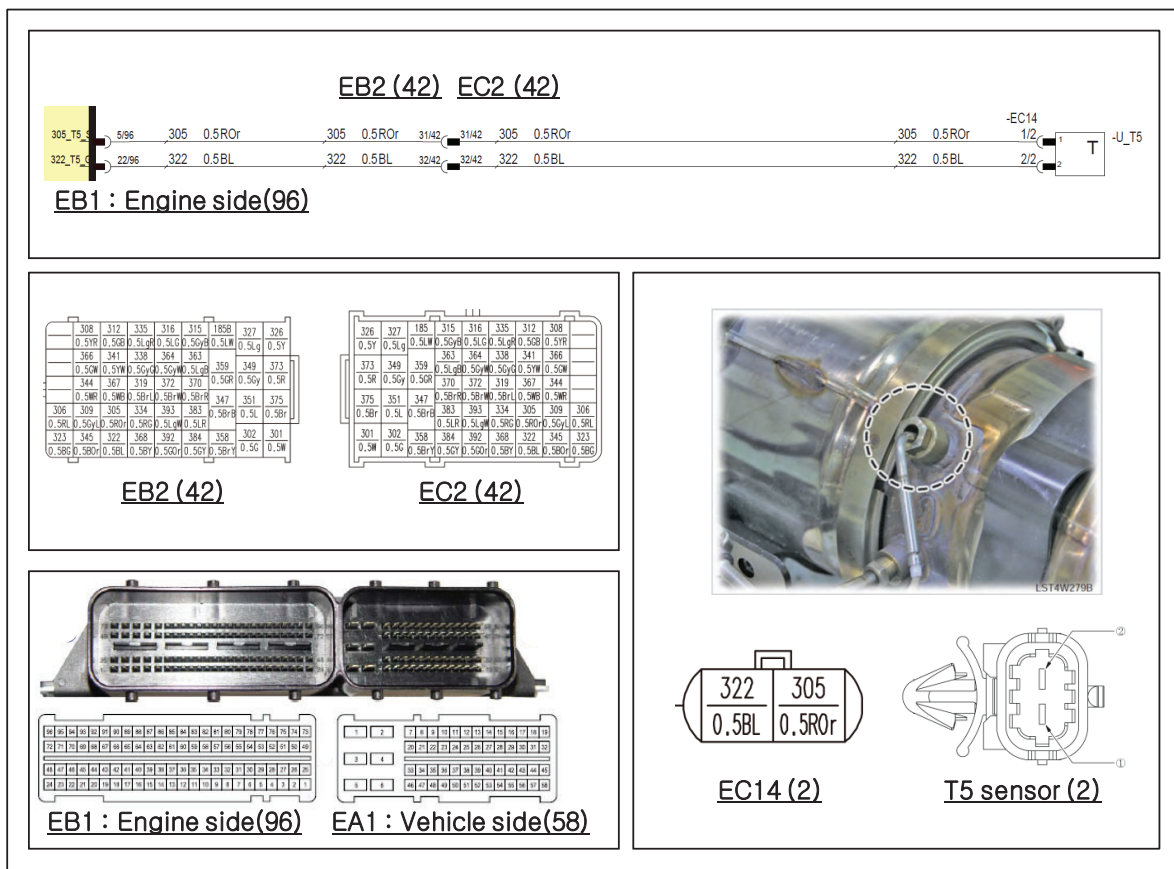
## Circuit Diagram and Connector

1. DPF regeneration stop
2. EGR valve control stop

Stage	Check List	Corrective Measure	
		Yes	No
1	Read fault code. Vext fault present? (P0641, P0651, P0697)	Go to stage 2	Go to stage 3
2	Problem with one of the sensors causing loss of Vext: Disconnect sensors one by one checking if fault disappear to find which one is faulty. If no faulty found, check short circuit and isolation of Vext lines on the harness. Find the failure cause?	Change sensor or change harness	–
3	Check sensor connection. Sensor connection problem ?	Perform necessary repair	Go to stage 4
4	Check sensor resistance, <sup>1)</sup> If applicable. Resistance problem ?	Change sensor	Go to stage 5
5	Check ECU connection. Connection problem ?	Perform necessary repair	Go to stage 6
6	Check continuity and electrical isolation of harness. <sup>2)</sup> • Check EC15 connector 1/2pin on EC2 connector 31/42pin • Check EC15 connector 2/2pin on EC2 connector 32/42pin • Check EB1 connector 5/96pin on EB2 connector 31/42pin • Check EB1 connector 22/96pin on EB2 connector 32/42pin Harness problem?	Change harness	Call Hot–line
