# 3 point YM2210D

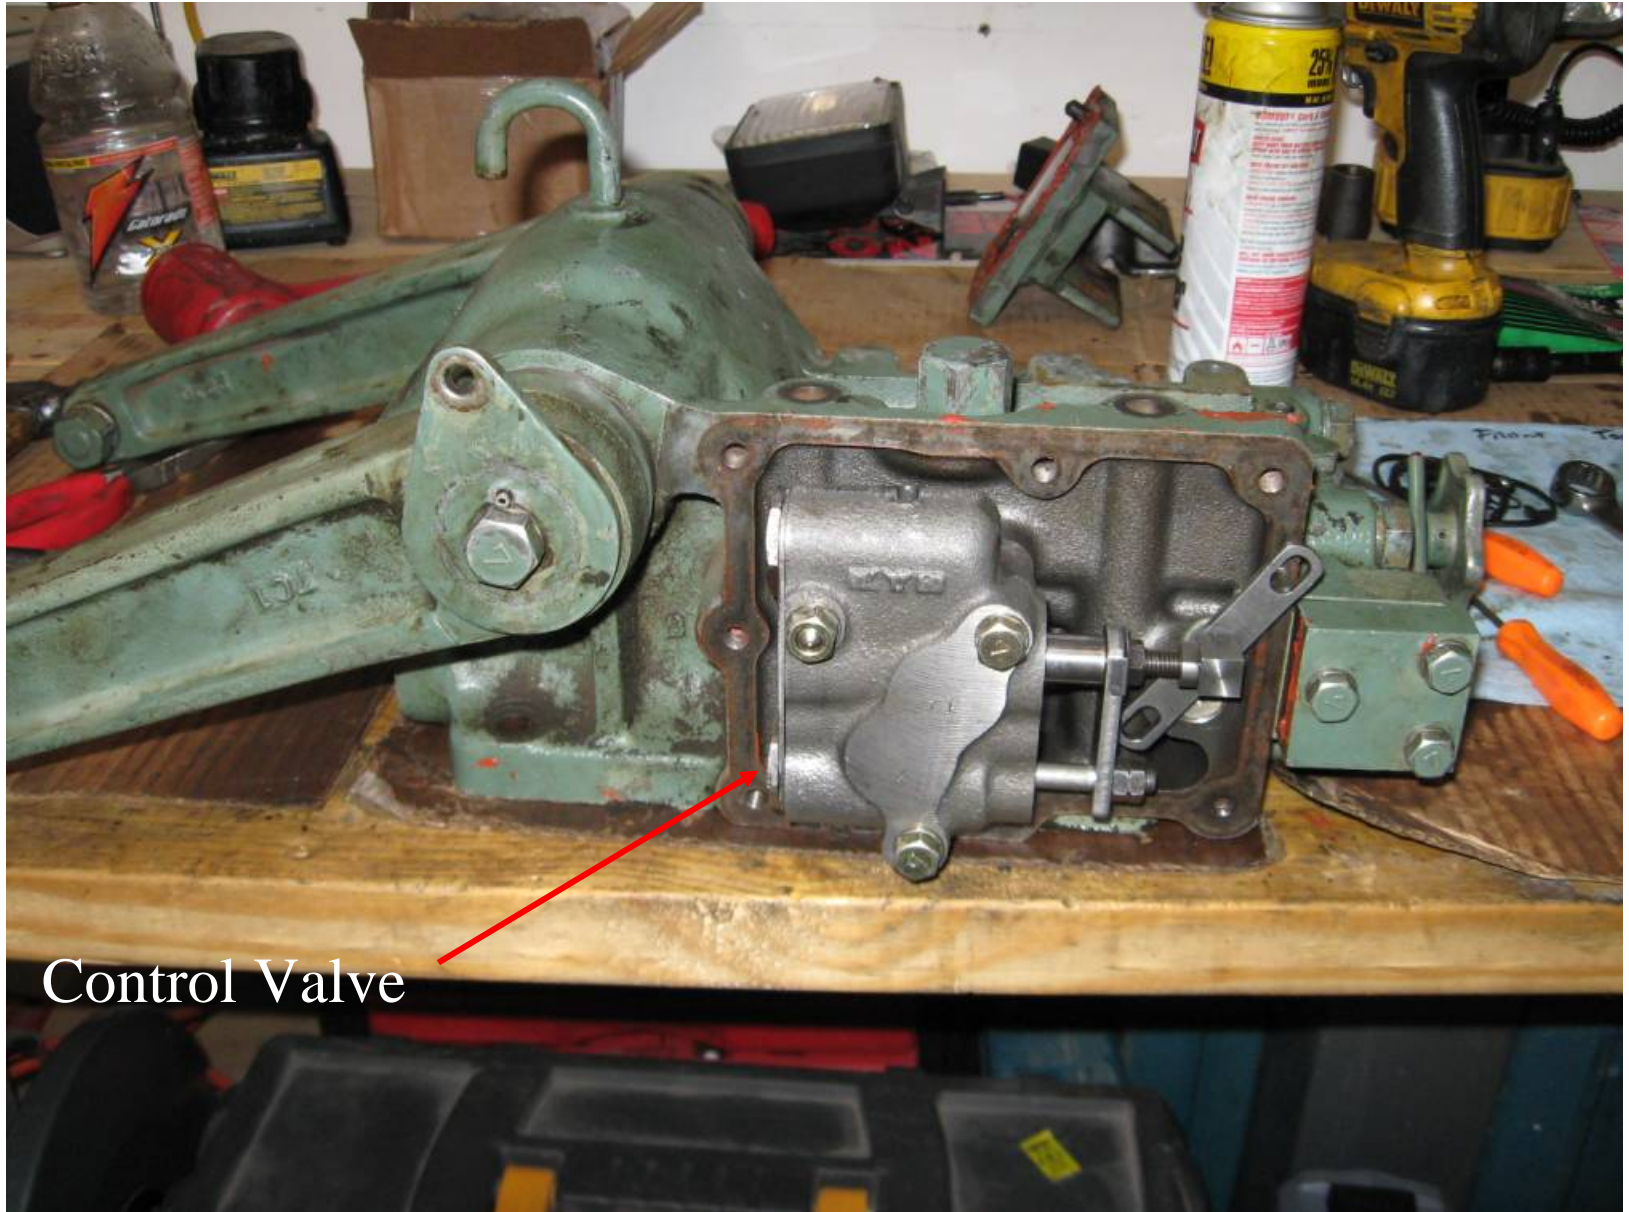
Control Valve

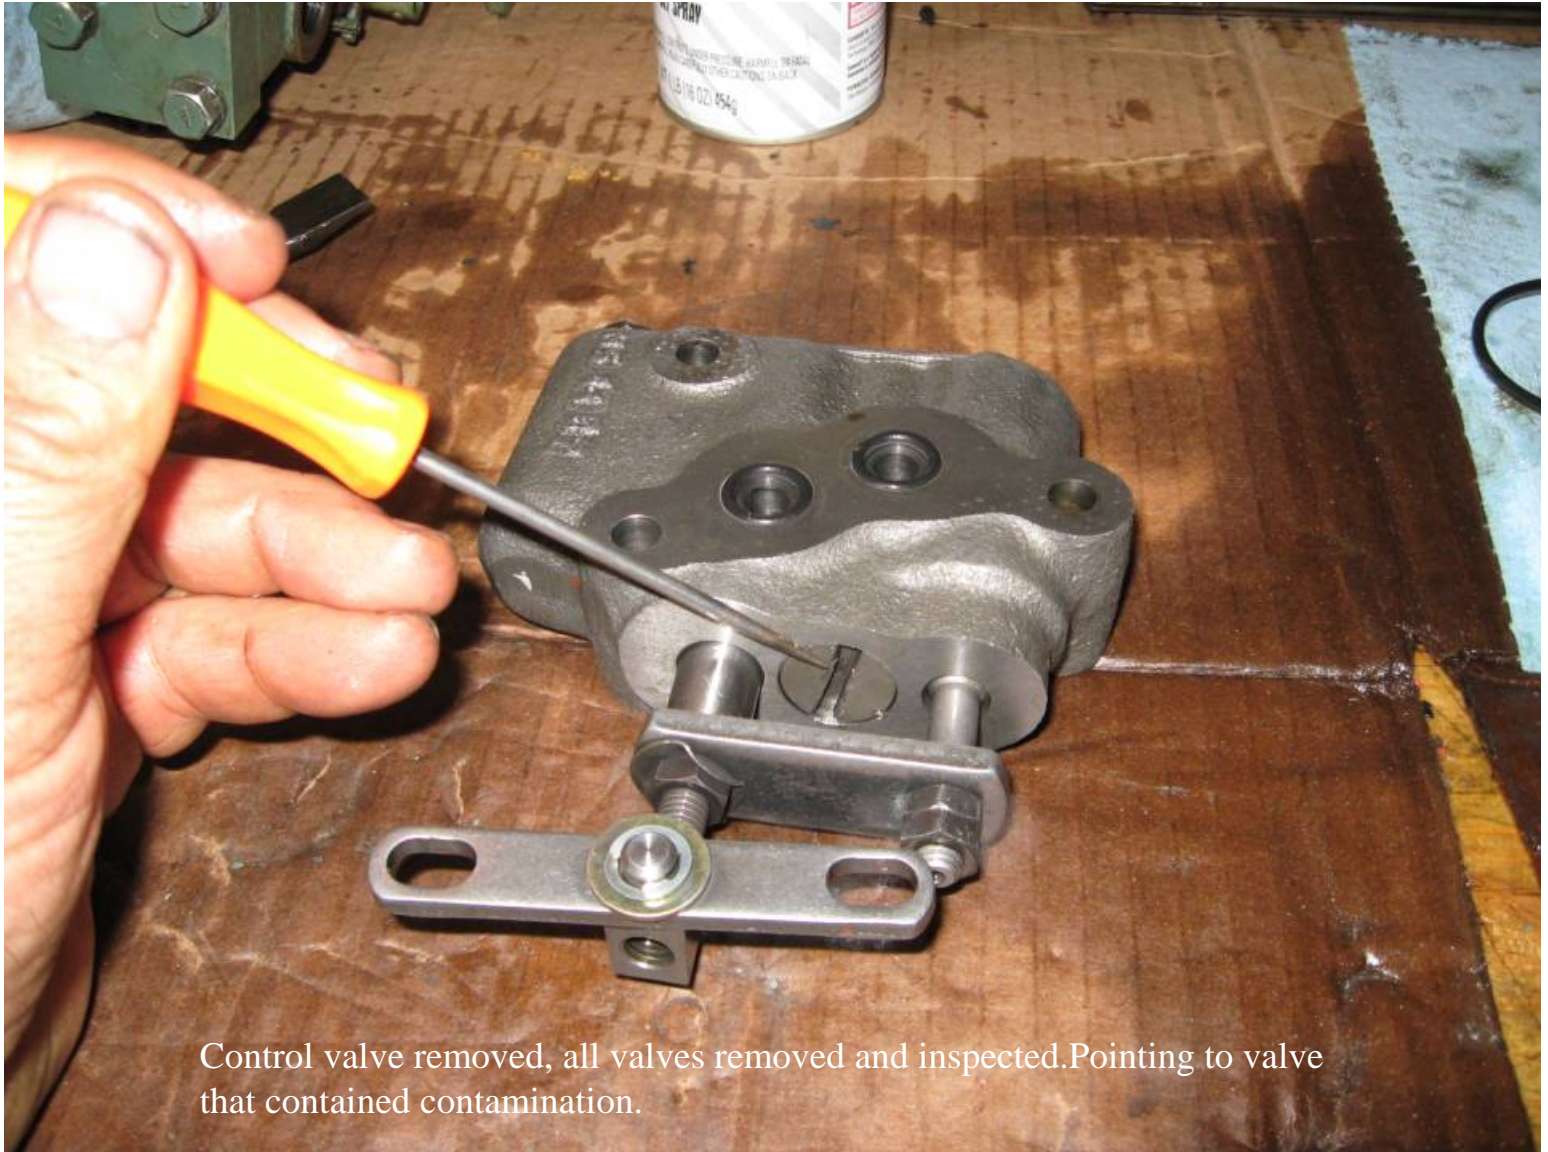
Control valve removed, all valves removed and inspected. Pointing to valve that contained contamination.

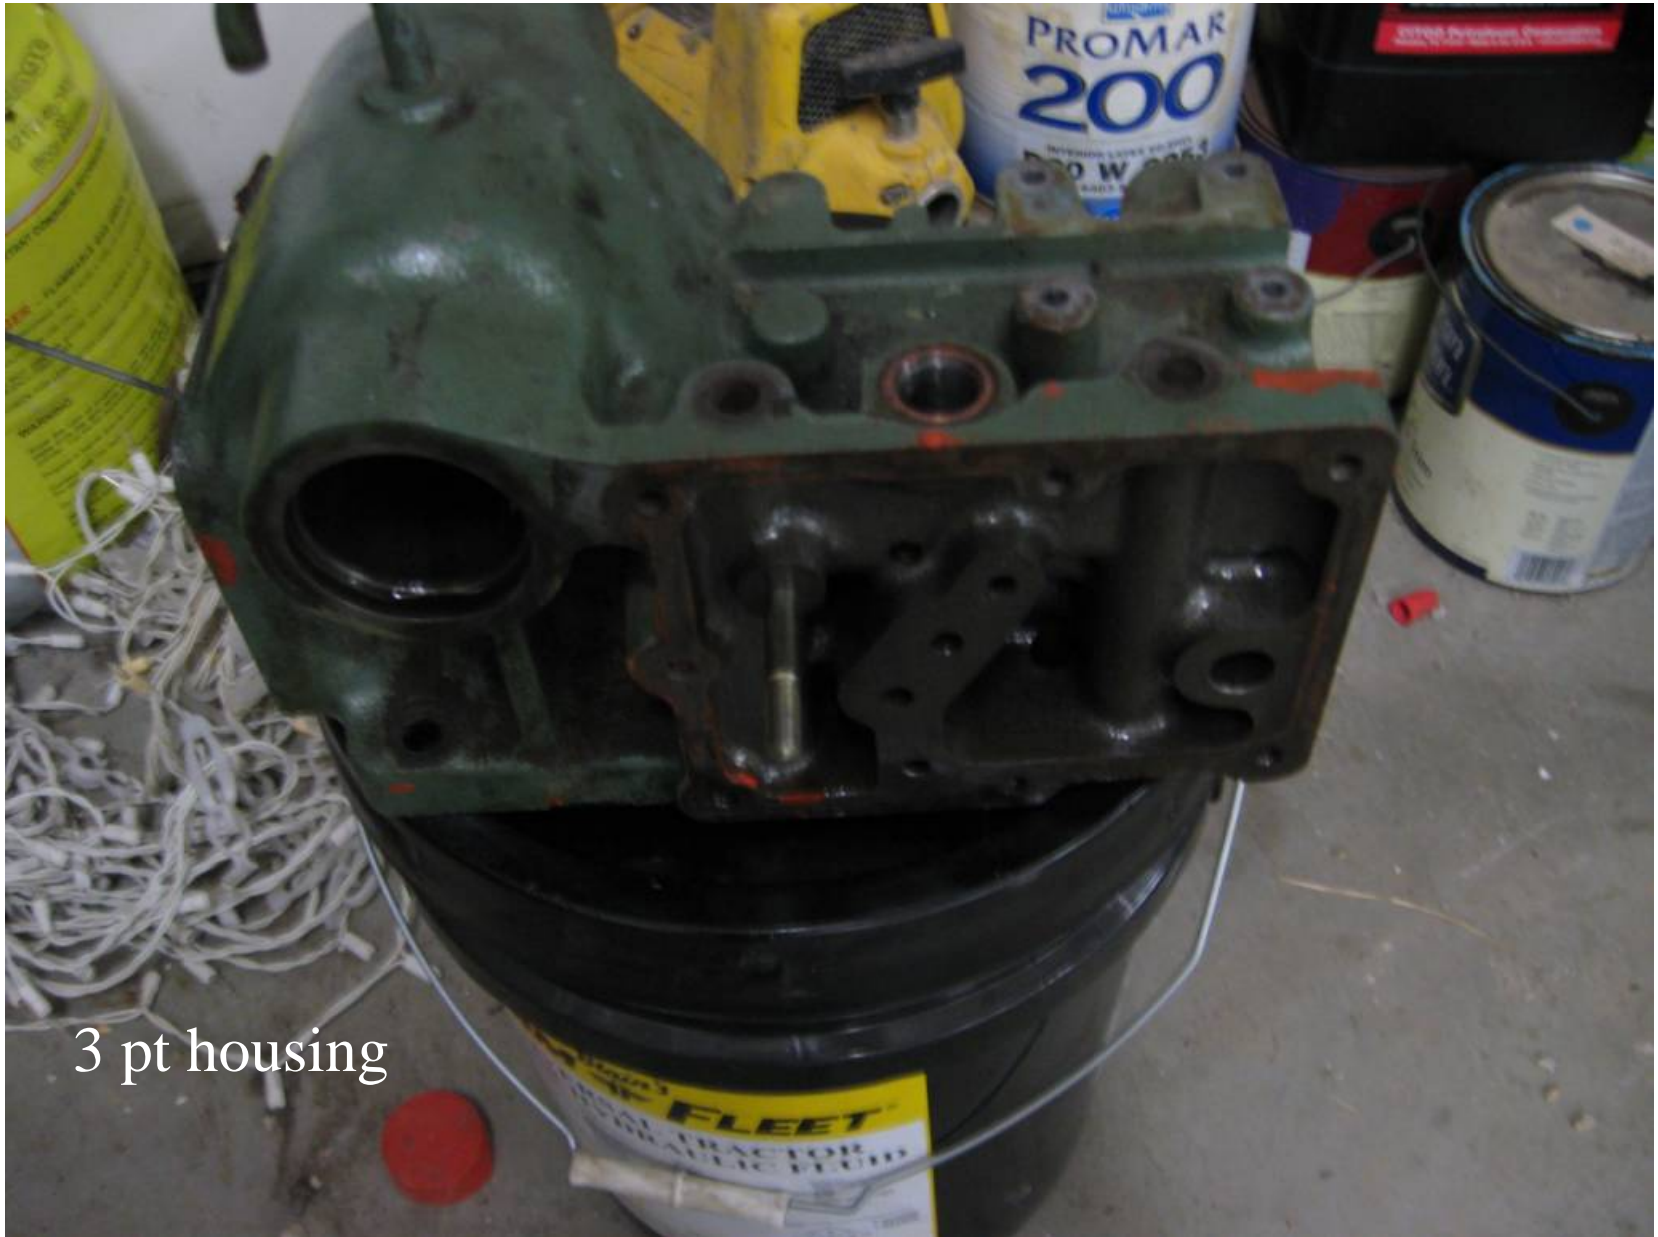
3 pt housing

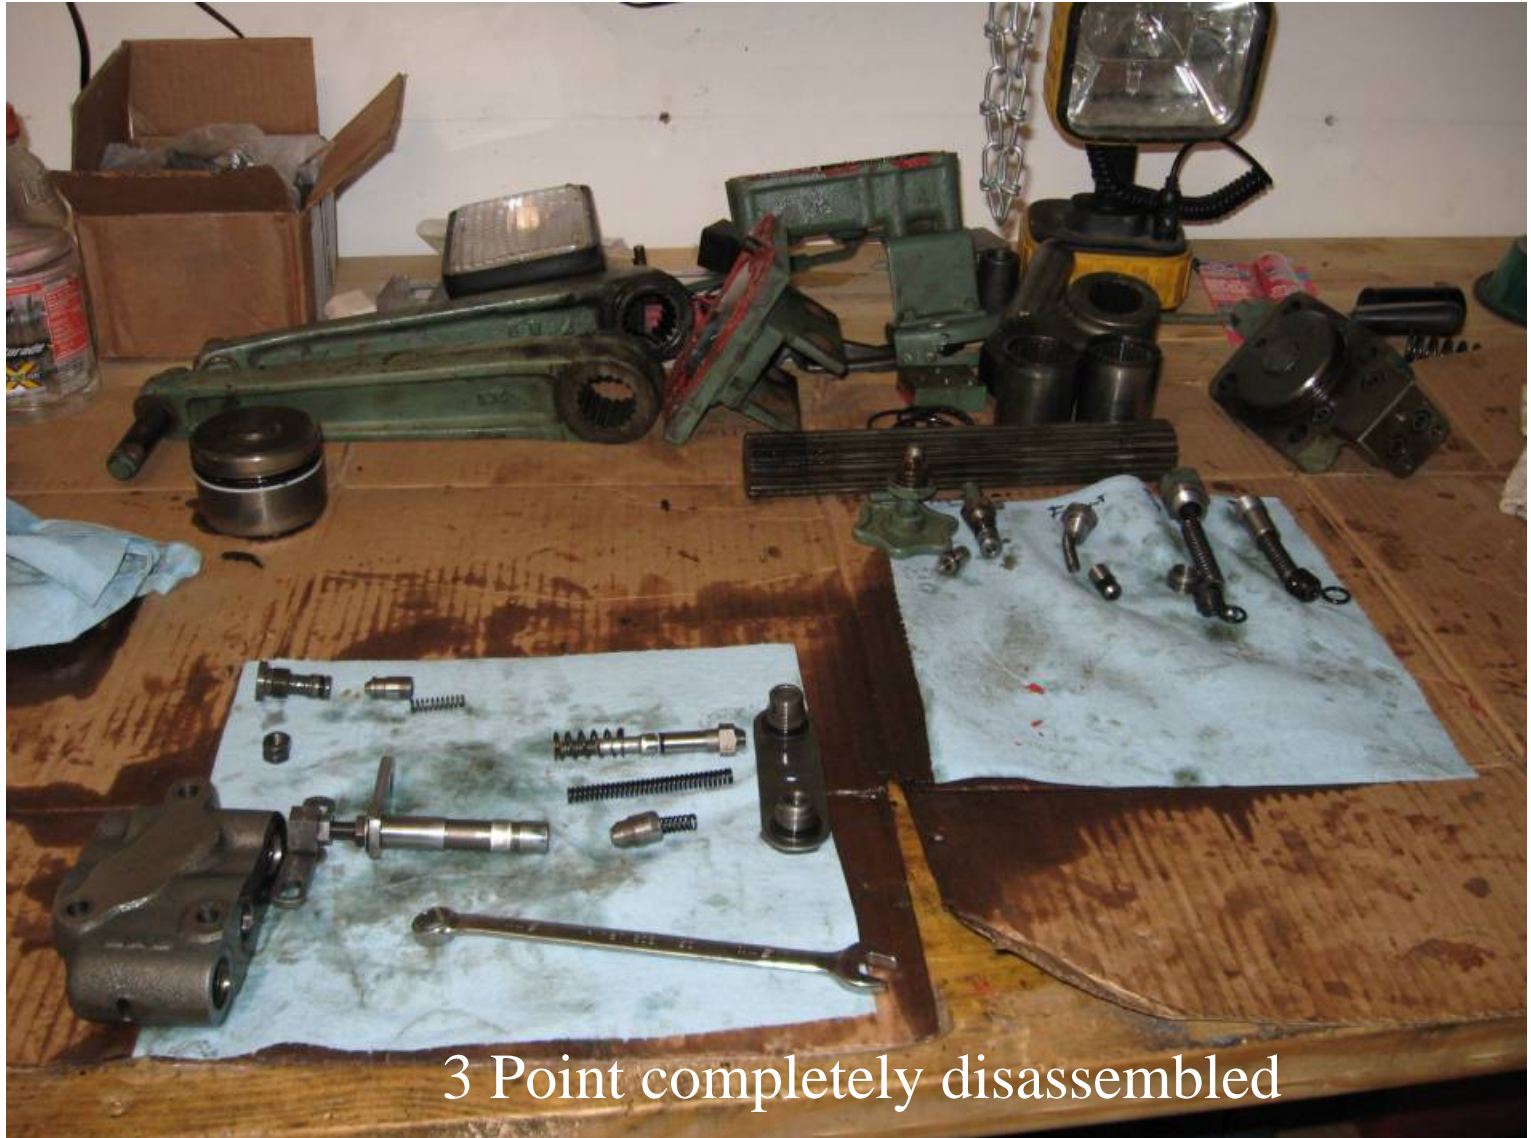
3 Point completely disassembled

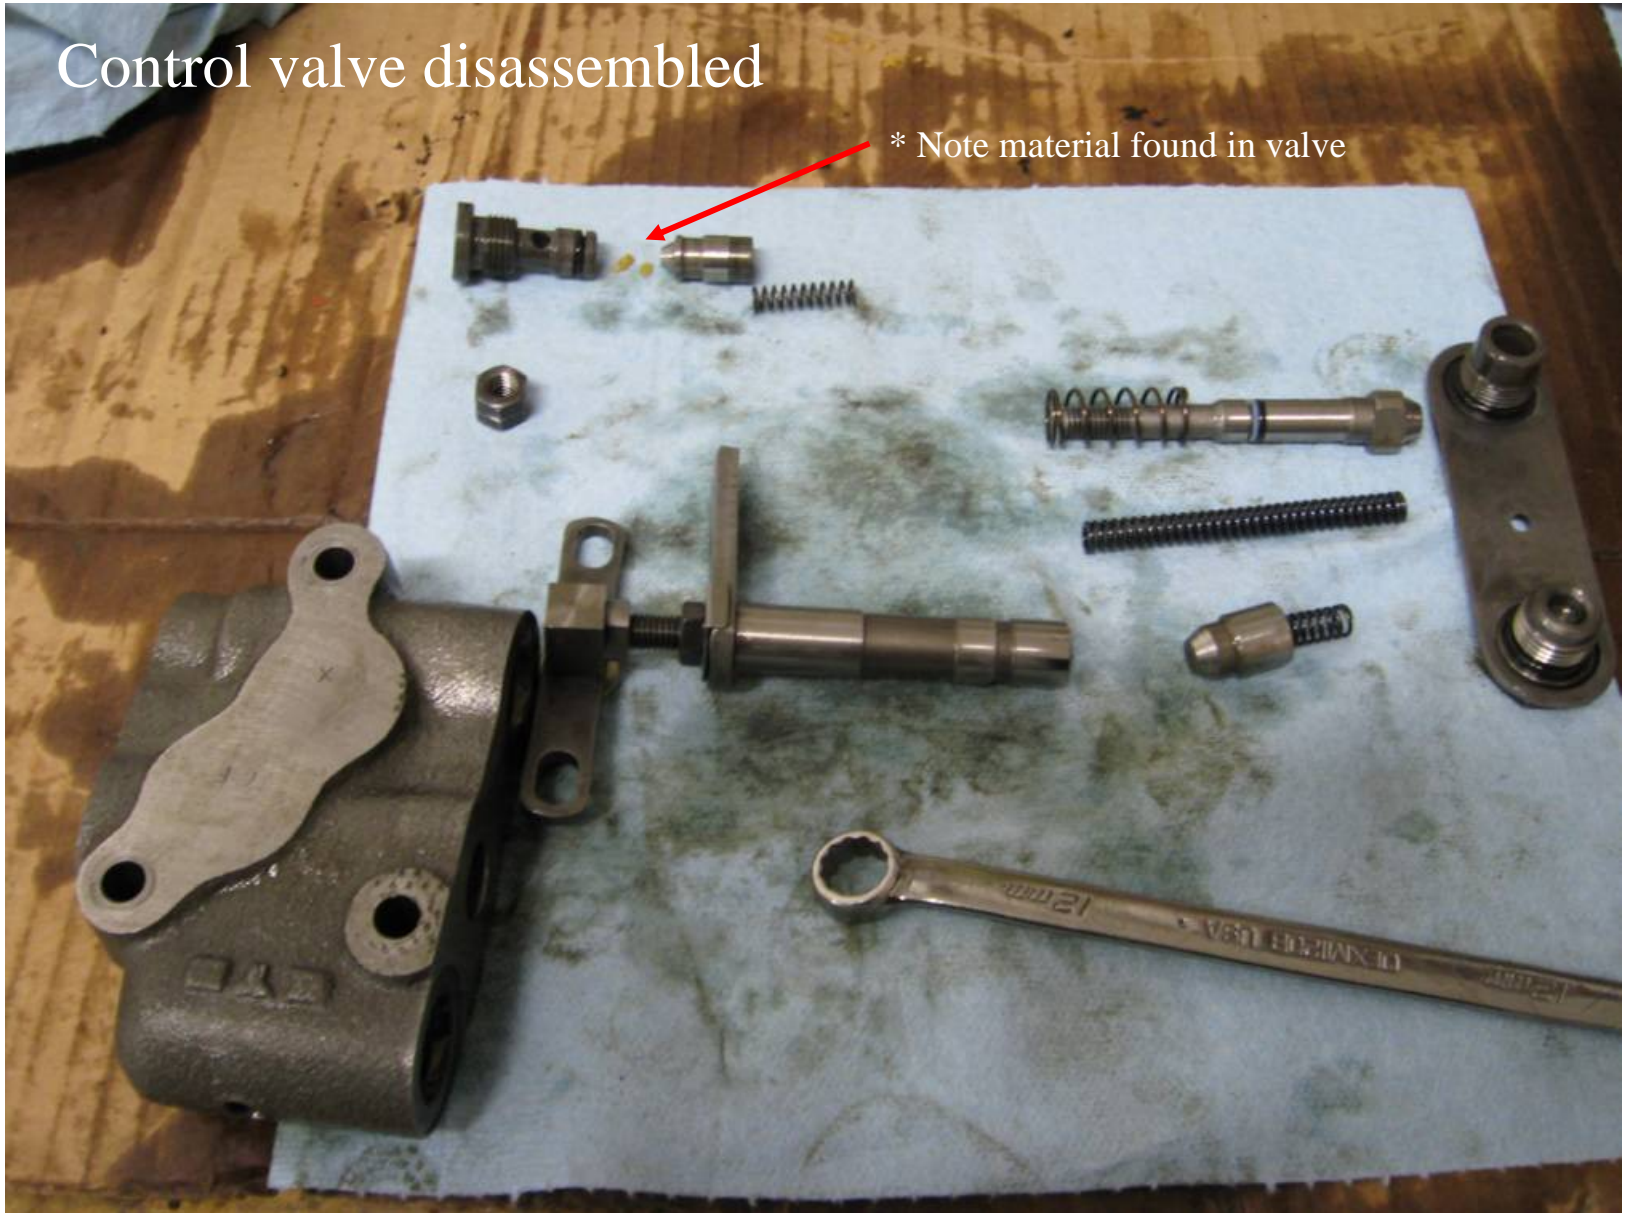
Control valve disassembled

\* Note material found in valve

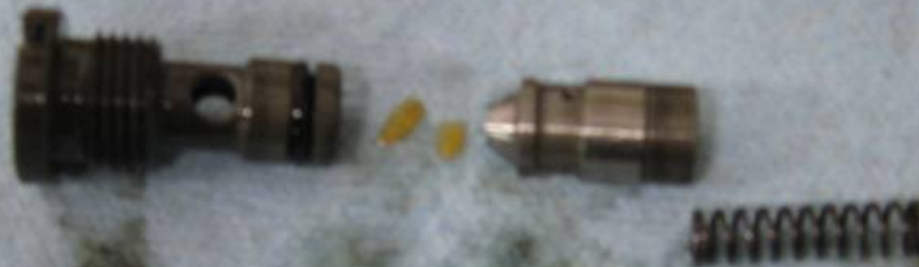
Close up of valve and material found. Material looks like a back-up seal or pump gland seal.

3 pt, was resealed and reassembled and was tested and performed much better no “bounce “
