Thermostat Installation

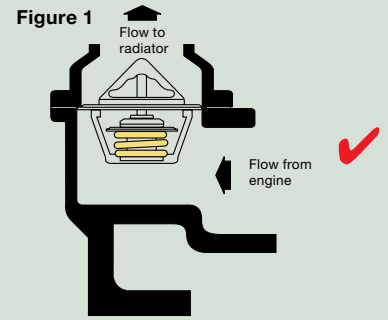
Conventional Thermostat Application - Correct

Figure 1 shows the installation of the correct conventional style thermostat. When the engine is cold the primary valve is closed preventing the flow of coolant to the radiator. As the engine reaches the predetermined temperature the primary valve opens. Full coolant flow is directed through the primary valve towards the radiator.

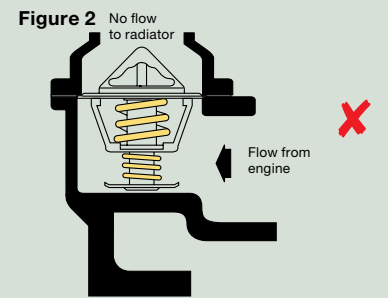
Conventional Thermostat Application - Incorrect

Figure 2 shows the installation of an incorrect bypass thermostat in a conventional (non-bypass) application.

When the engine is cold the primary valve is closed preventing the flow of coolant to the radiator. As the engine reaches the predetermined temperature the primary valve **cannot** open due to the restriction of the secondary valve by the design of the assembly. As a result coolant cannot circulate through the engine cooling system, **significant engine damage may result as part of this incorrect installation.**

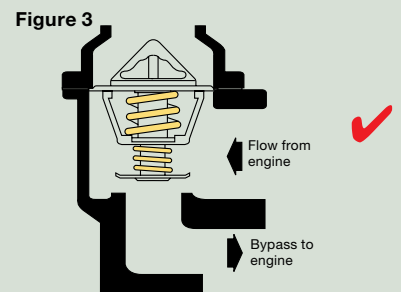
Bypass Thermostat Application - Correct

Figure 3 shows the installation of the correct bypass style thermostat.

When the engine is cold the primary valve is closed preventing the flow of coolant to the radiator. The secondary valve is open directing the flow of coolant back through the engine bypass valve allowing the engine temperature to rise quickly. As the engine reaches the predetermined temperature the primary valve opens and the secondary valve closes over the bypass valve.

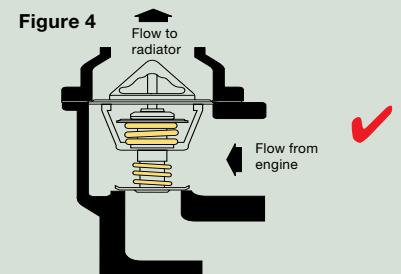
Figure 4 shows the primary valve in the fully open position and the secondary valve blocking the engine bypass valve inside the assembly. Full coolant flow is directed through the primary valve towards the radiator.

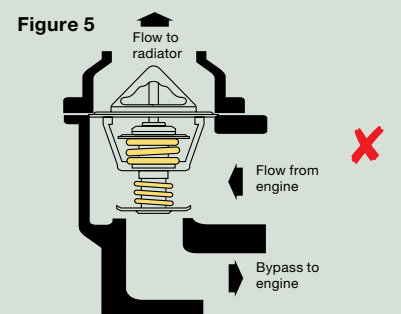
Bypass Thermostat Application - Incorrect

Figure 5 shows the installation of an incorrect bypass thermostat in a bypass application. The primary valve is in the fully open position; the secondary valve is **not** blocking the engine bypass valve inside the assembly.

Only partial flow of coolant is directed towards the radiator, the remaining hot coolant continues to circulate through the system via the engine bypass valve. As a result the cooling efficiency system is reduced leading to higher engine temperatures and potential premature failure of other components within the cooling system.

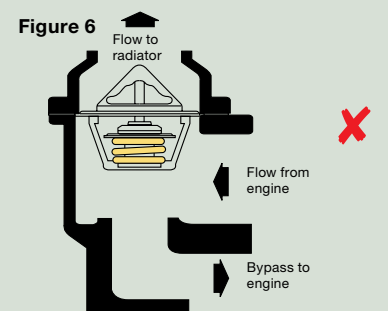
Bypass Thermostat Application - Incorrect

Figure 6 shows the installation of an incorrect conventional (non-bypass) thermostat in a bypass application.

The conventional thermostat without a foot valve allows unrestricted flow of the hot coolant through the system via the engine bypass valve whilst primary valve is in the full open position. As a result the cooling efficiency system is greatly reduced leading to much higher engine temperatures and potential premature failure of other components within the cooling system.
